Lumineers with Cerinate (2009 PPL)

Den-Mat Holdings LLC
800.433.6628 - 805.922.8491
www.denmat.com

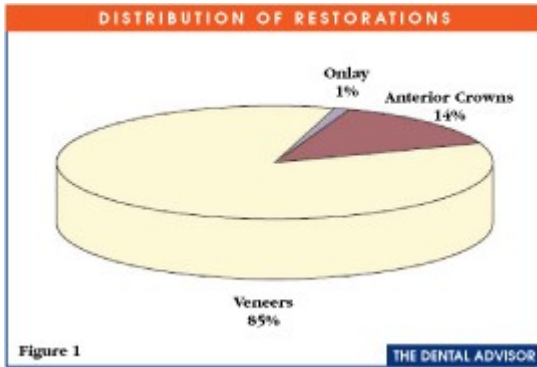
- Two hundred sixty-nine restorations were placed in 61 patients. These included 39 anterior crowns, 228 veneers and one onlay (Figure 1).
- Fifty-four of the 228 veneers were placed on teeth prepared using the minimal reduction technique. Twelve veneers were placed on unprepared teeth. One veneer was placed on an existing ceramic-metal crown where the facial ceramic had fractured (Figure 2).
- Restorations ranged in age from one to four years (Figure 3).
- Restorations were fabricated by Nellmar Laboratory, Ann Arbor, MI.
- Lumineers were bonded with Ultra-Bond Plus with Tenure MPB.
- Restorations were evaluated on a 1-5 scale:
1 = poor, 2 = fair, 3 = good, 4 = very good, 5 = excellent.

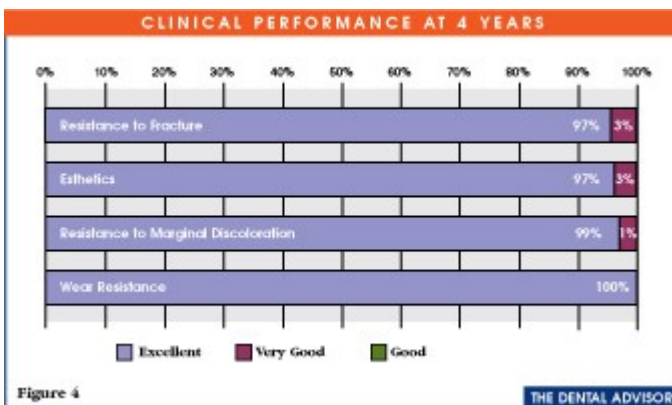
During the four-year clinical evaluation of Lumineers, five patients experienced chips or fractures of their restorations, including six anterior veneers and one premolar of traditional thickness (Figure 4). Six restorations were replaced and one was polished. All fractures occurred during the first year of placement. Three anterior veneers of minimal preparation and one veneer of traditional preparation debonded and were recemented.

Lumineers continue to provide excellent esthetics and vitality after four years in service. The life-like appearance and gloss have been maintained from the time of insertion. Of the 269 restorations placed, nine restorations on two patients exhibited surface stain which was readily removed with a ceramic polishing system (Figure 4). The stain has not returned.

No microleakage was reported in 99% of Lumineers (Figure 4). During the first year in service, two anterior veneers experienced black marginal staining and were replaced. No additional microleakage has occurred.

No visible wear was noted on any of the Lumineers (Figure 4). No wear of opposing dentition was attributed to the ceramic.
